4A- IF THE ELEVATOR DOES NOT SLOW DOWN WHEN REACHING FLOOR LEVEL

15/650 l/min distributor (including 2-speed HL)

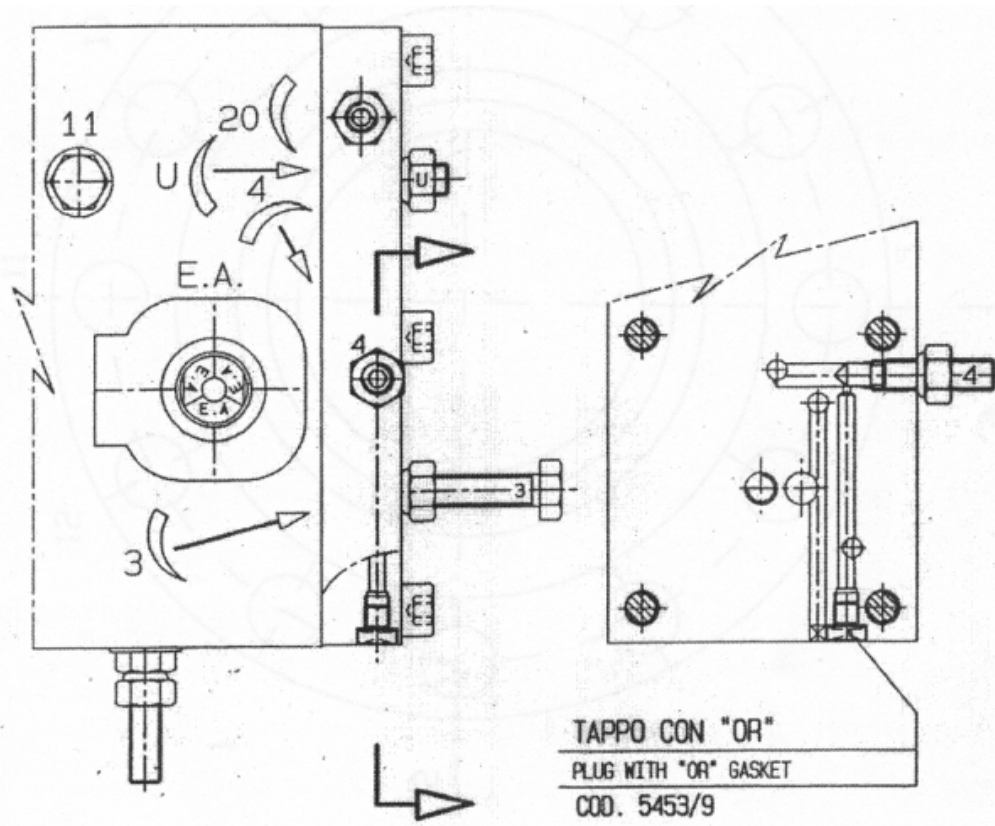
- 1- Make sure that EA electrovalve is not energized
- 2- Verify the correct positioning of the deceleration magnets on the guide rails: these should be placed following MORIS graph (X2- XP1 and Y2 – YP0), written on power unit test report
- 3- Check the regulation of screw # 4: it should be completely closed and unscrewed of 4 turns; if it is too closed, it can cause the defect
- 4- Verify the correct operation of the manual button on electrovalve EA
- 5- Disassemble electrovalve EA and clean the passage from any dirt found inside
- 6- Problem inside the oil path in plate 0448 (repair **R8A**)

R8A, plate of regulation # 4: Reference to drawing 0531/1-V4 (see drawing below)

- Take the car at the lowermost floor
- switch off the motor power supply
- Unscrew, with a screwdriver the cap positioned beside the plate 0448
- Place a rag on the cap hole
- Press the manual button of electrovalve EB, and let oil flow outside the cap hole
- Place the cap back on plate
- Test the elevator
