## Group B

### Possible operating issues of 8/23 l/min distributor

#### Home Lift – My Lift (Single speed)

**DISTRIBUTORE OLEODINAMICO "HL"**  
(8 / 28 L/MIN.)

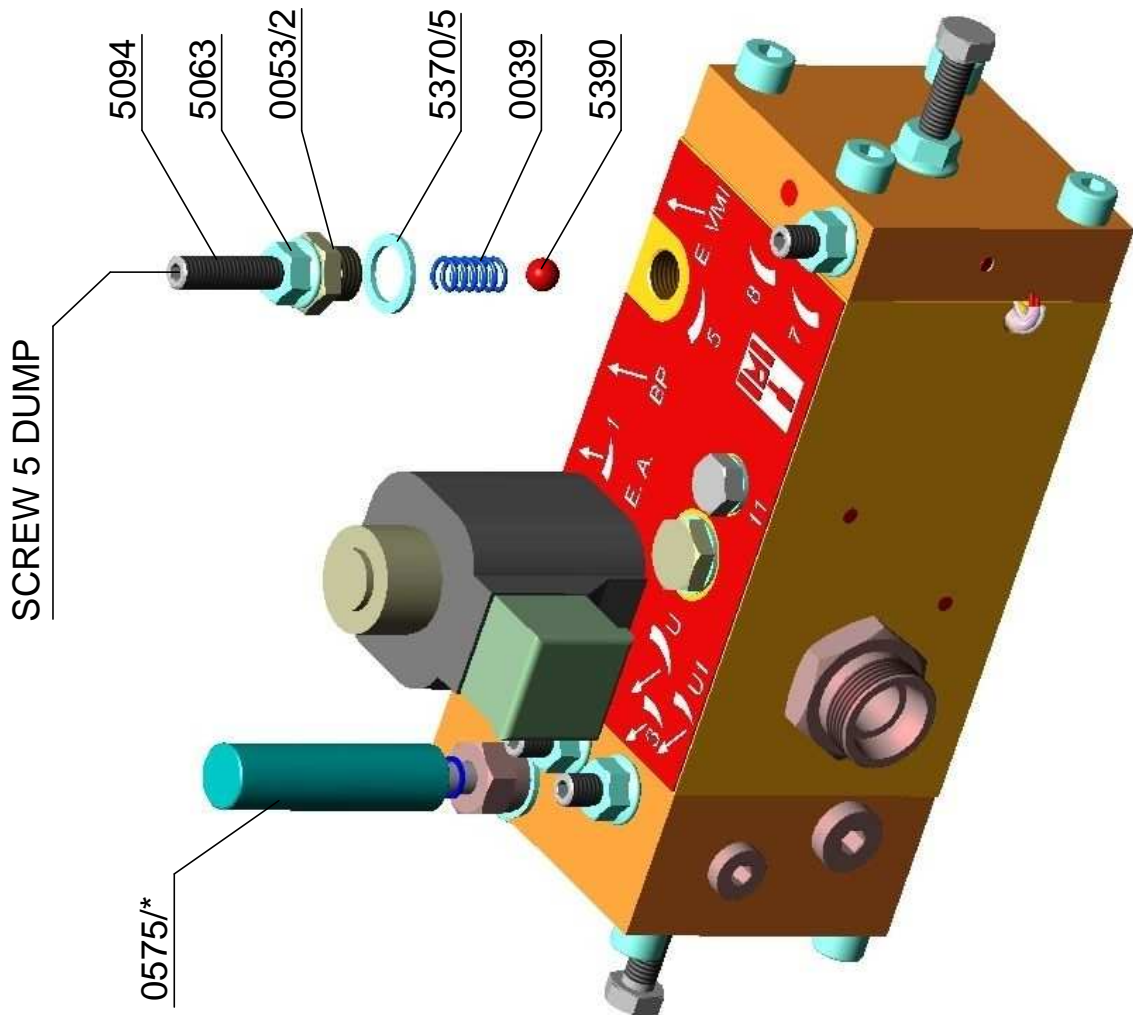
DATE
DWG Nr. <b>R1B</b>

- close the ball valve
- start the motor for drive in up direction and check that the pressure indicated by the manometer is corresponding to the nominal overpressure (“PS” in the label), written on power unit label
- if the measured value is different than the nominal one, screw reg # 5 until the measured pressure is 1.4 times the value of Max working pressure (1.4 x “PE max” on the label)
- if the read value is correct, eliminate the pressure inside the distributor, pushing the manual descent button (0575/\* )
- switch off the motor power supply
- disassemble the screw #5
- clean the sphere from any dirt you may find
- assemble the components in the following order: sphere, spring (put the larger diameter in contact with the sphere) and screw
- test the elevator

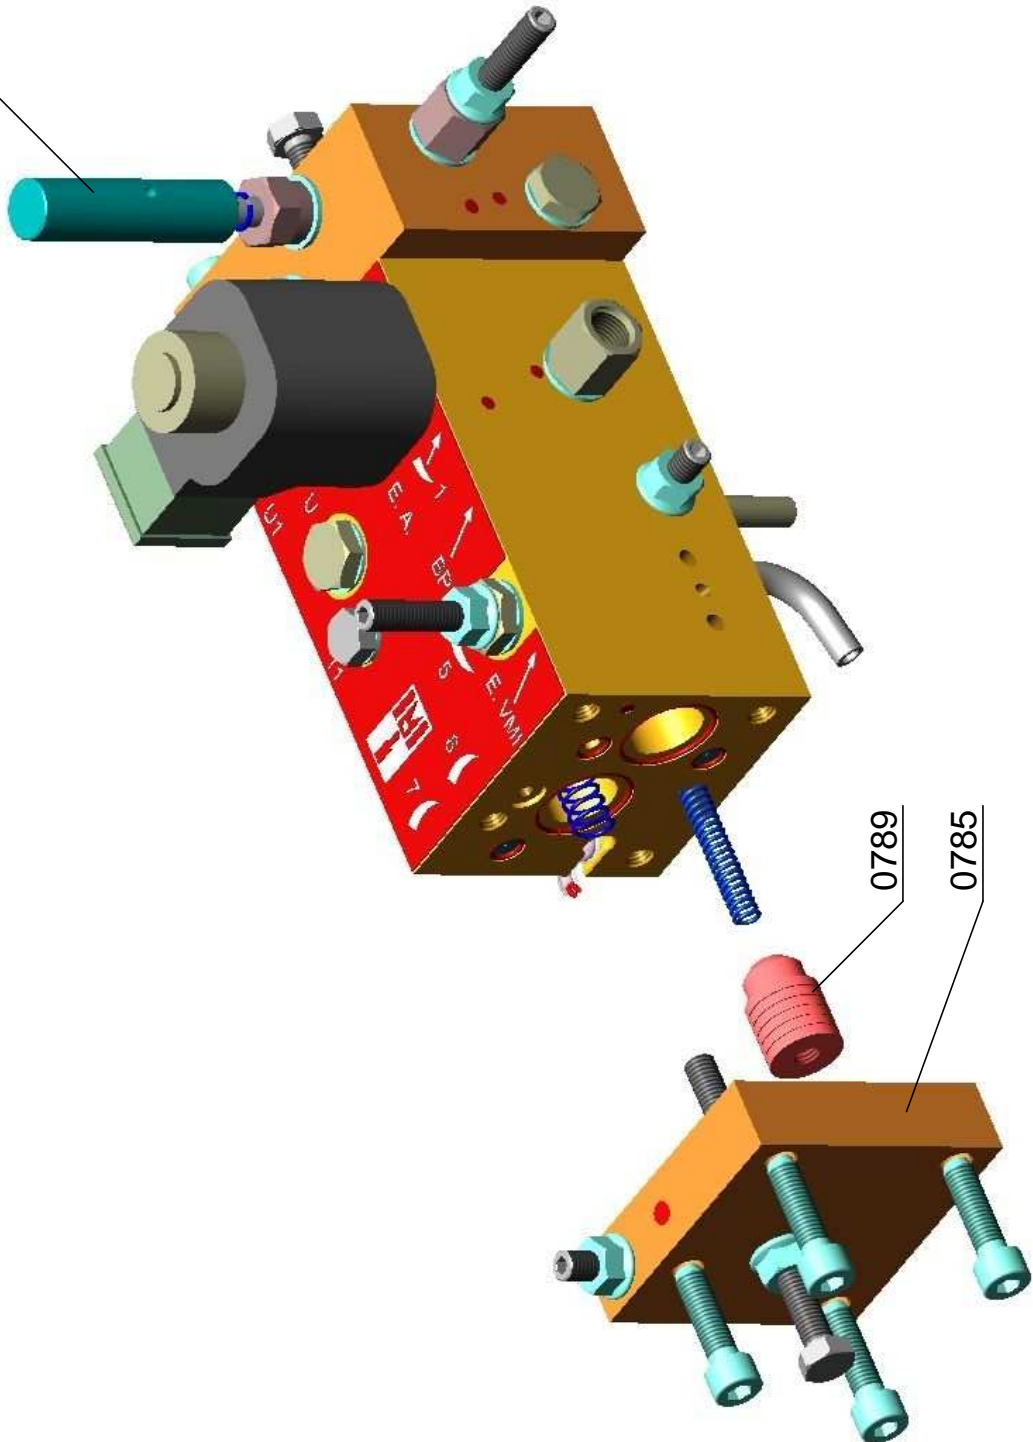
DATE
DWG Nr. <b>R2B</b>

- close the ball valve
- eliminate the pressure inside the distributor, pushing the manual descent button (0575/\* )
- switch off the motor power supply
- disassemble plate 0785, taking care of the pieces inside
- verify that the sliding of piston 0036 is smooth and not obstructed; clean any dirt inside
- assemble all pieces and test the elevator

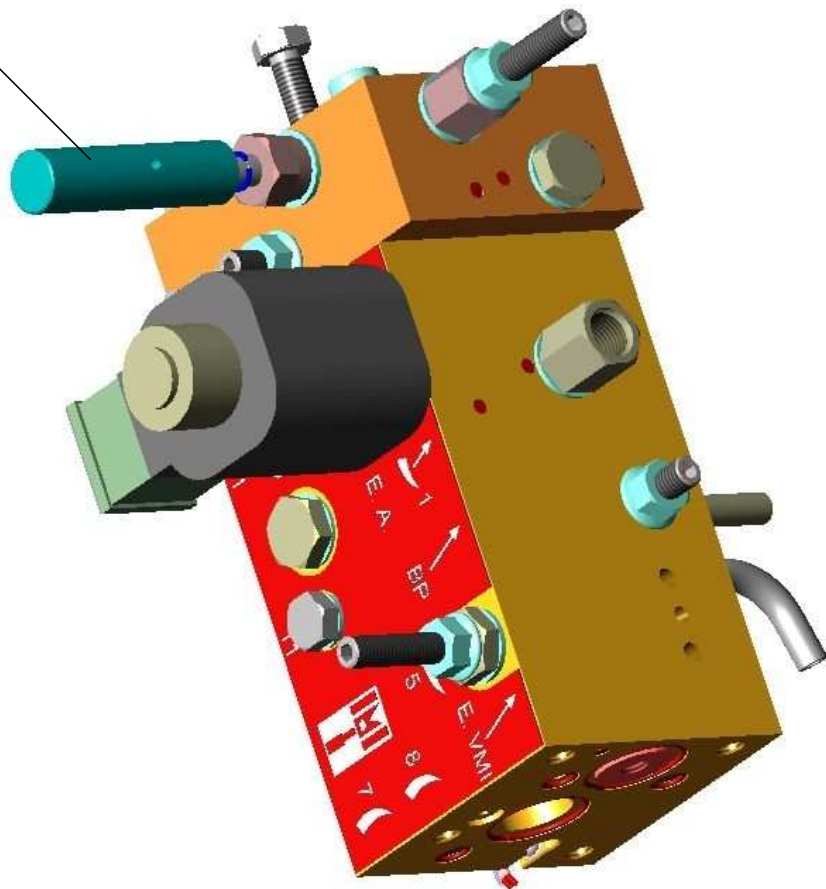
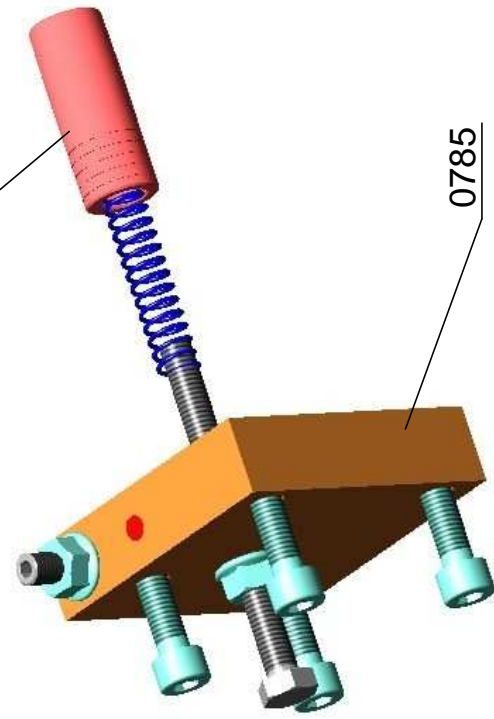
DATE
DWG Nr. <b>R4B</b>

- close the ball valve
- eliminate the pressure inside the distributor, pushing the manual descent button (0575/\* )
- switch off the motor power supply
- disassemble plate 0785, taking care of the pieces inside
- verify that the sliding of piston 0789 is smooth and not obstructed
- if piston 0789 is blocked, assemble the plate 0785 back without the spring; drive the elevator in up direction to unblock the piston
- disassemble the plate 0785, cleaning any dirt found
- assemble all pieces and test the elevator

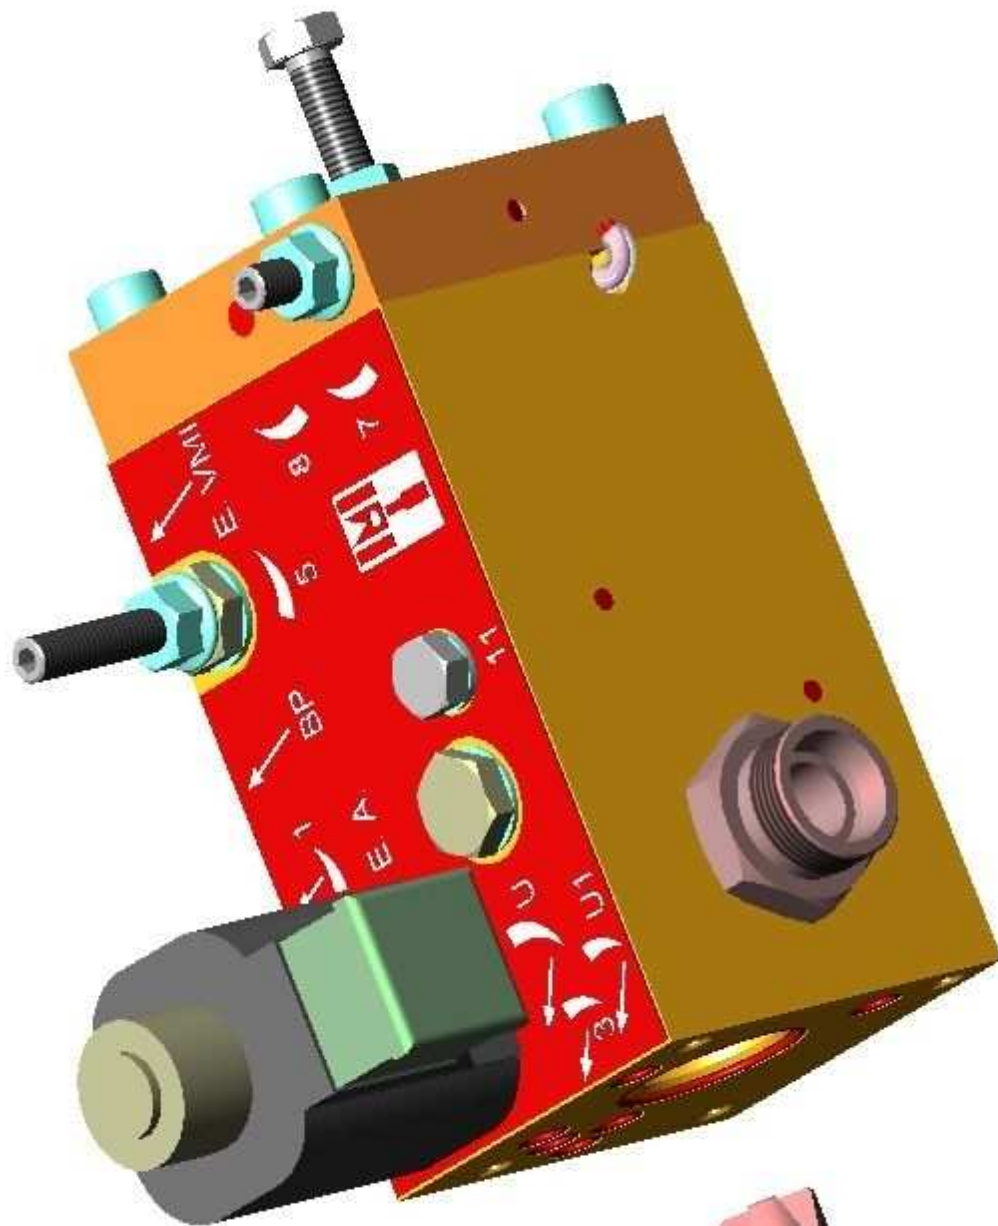
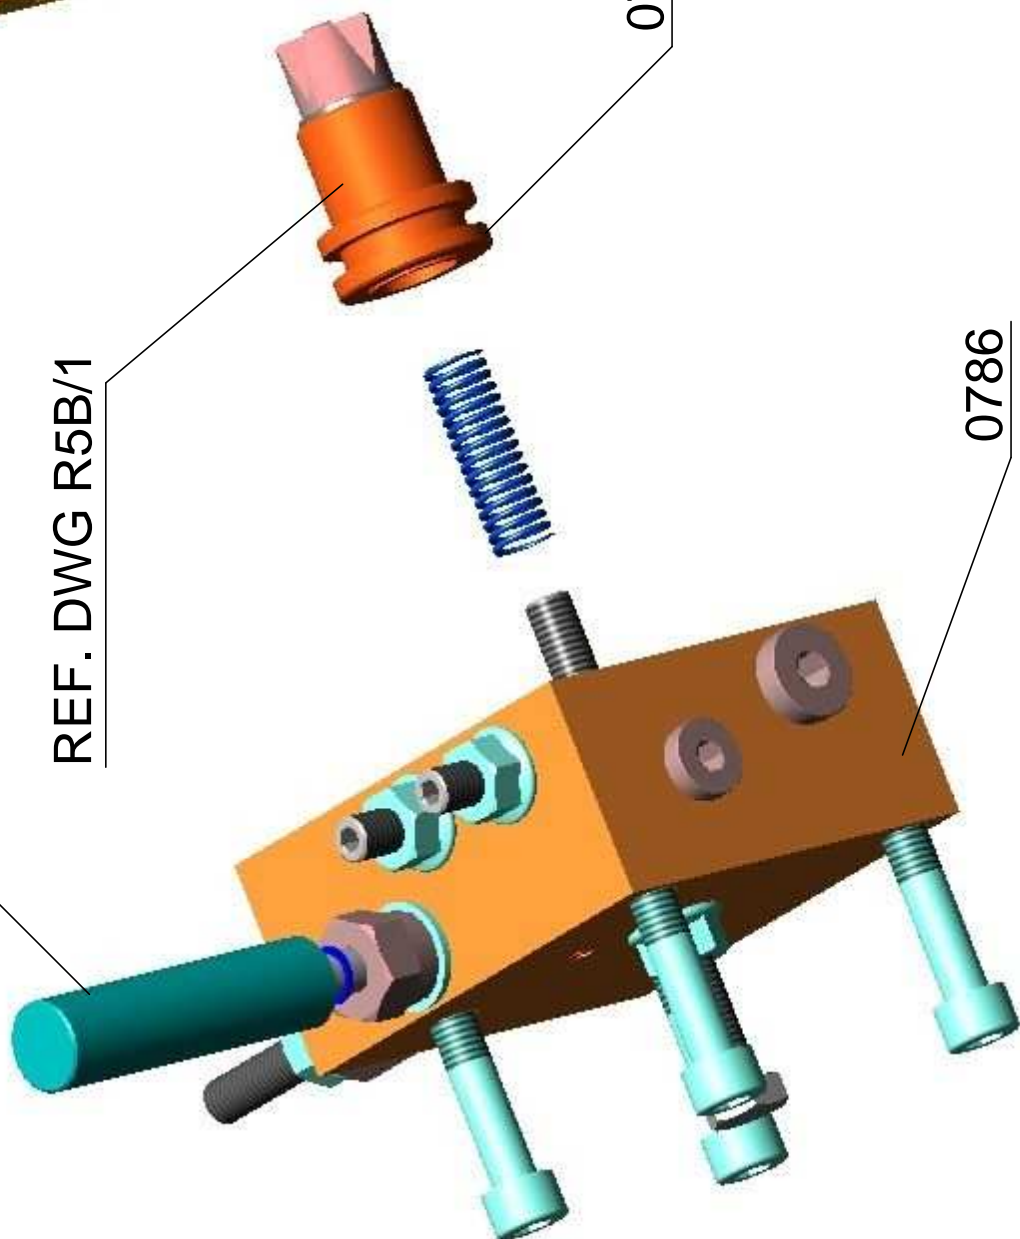
**R5B**

- close the ball valve
- eliminate the pressure inside the distributor, pushing the manual descent button (0575/\* )
- switch off the motor power supply
- disassemble the plate of regulation # 3, taking care of the pieces inside
- remove the little piston (spool) inside, behind the spring
- check that gasket (0791) is not damaged, and there is no dirt inside
- if gasket (0791) is damaged, it must be replaced, as described below
- unscrew the hex screw 5453/6, taking care not to damage piece 0788 and the guiding ring of particular 0787
- clean all traces of rubber inside the distributor
- re-assemble the spool valve and the plate that was previously removed
- test the elevator

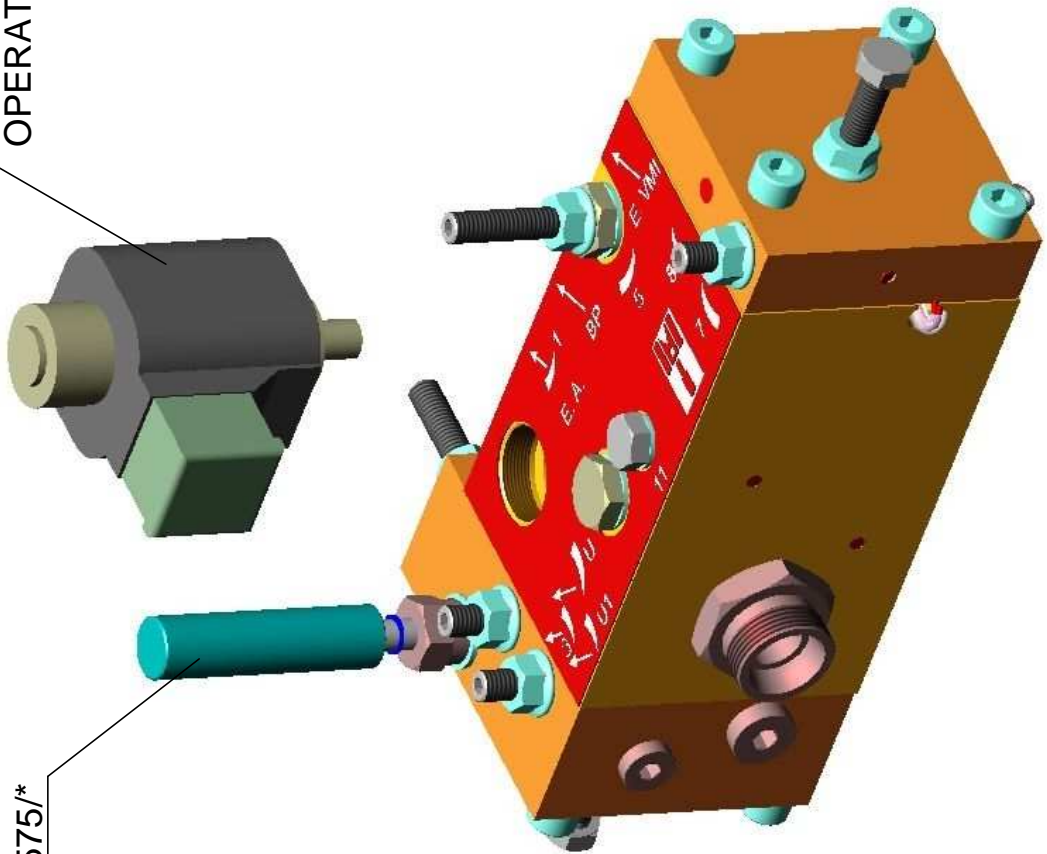
R6B

- close the ball valve
- eliminate the pressure inside the distributor, pushing the manual descent button (0575/\* )
- switch off the motor power supply
- remove the solenoid coil from electrovalve EA
- remove the electrovalve EA
- remove any trace of dirt you may find inside
- mount all pieces back in place
- test the elevator

E.A.  
OPERATING COIL

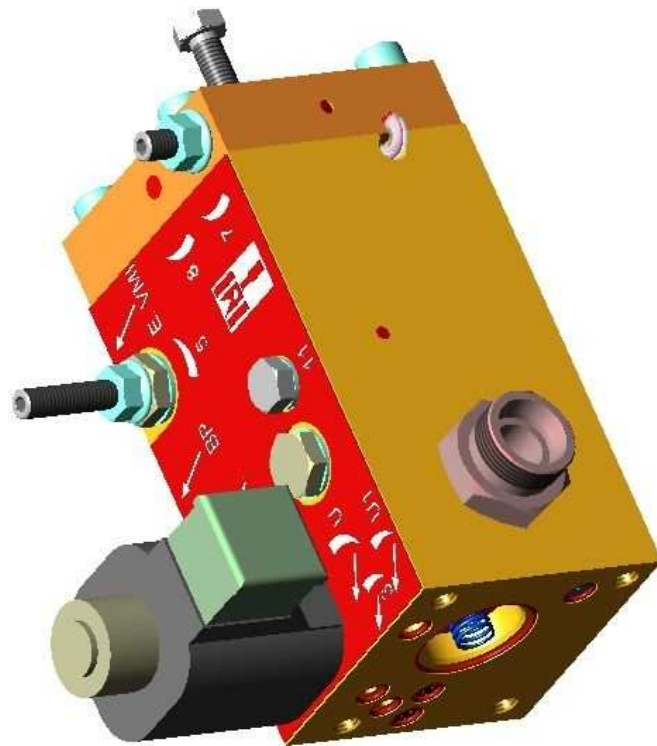
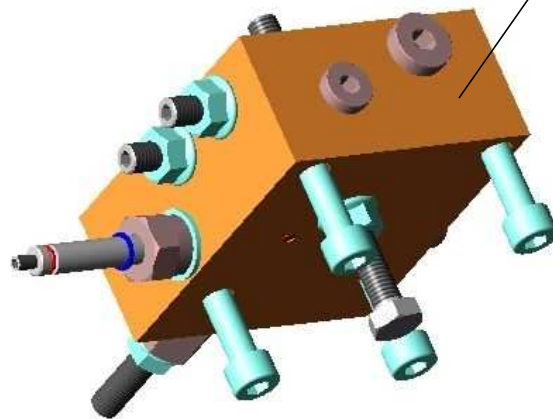
DATE
DWG Nr. <b>R7B</b>

- close the ball valve
- eliminate the pressure inside the distributor, pushing the manual descent button (0575/\* )
- switch off the motor power supply
- remove the manual descent button
- disassemble plate 0786, taking care of the pieces inside
- remove the button cap (found under the button rod), using an hexagon key (M8 screw)
- remove the pieces inside (both the spring and the sphere)

- clean carefully all the particulars and the sphere seat
- if a spare sphere is available, replace the existing sphere with a new one
- assemble the components in the following order: sphere, spring (put the smaller diameter in contact with the sphere) and button cap
- put back in place the manual descent button
- test the elevator

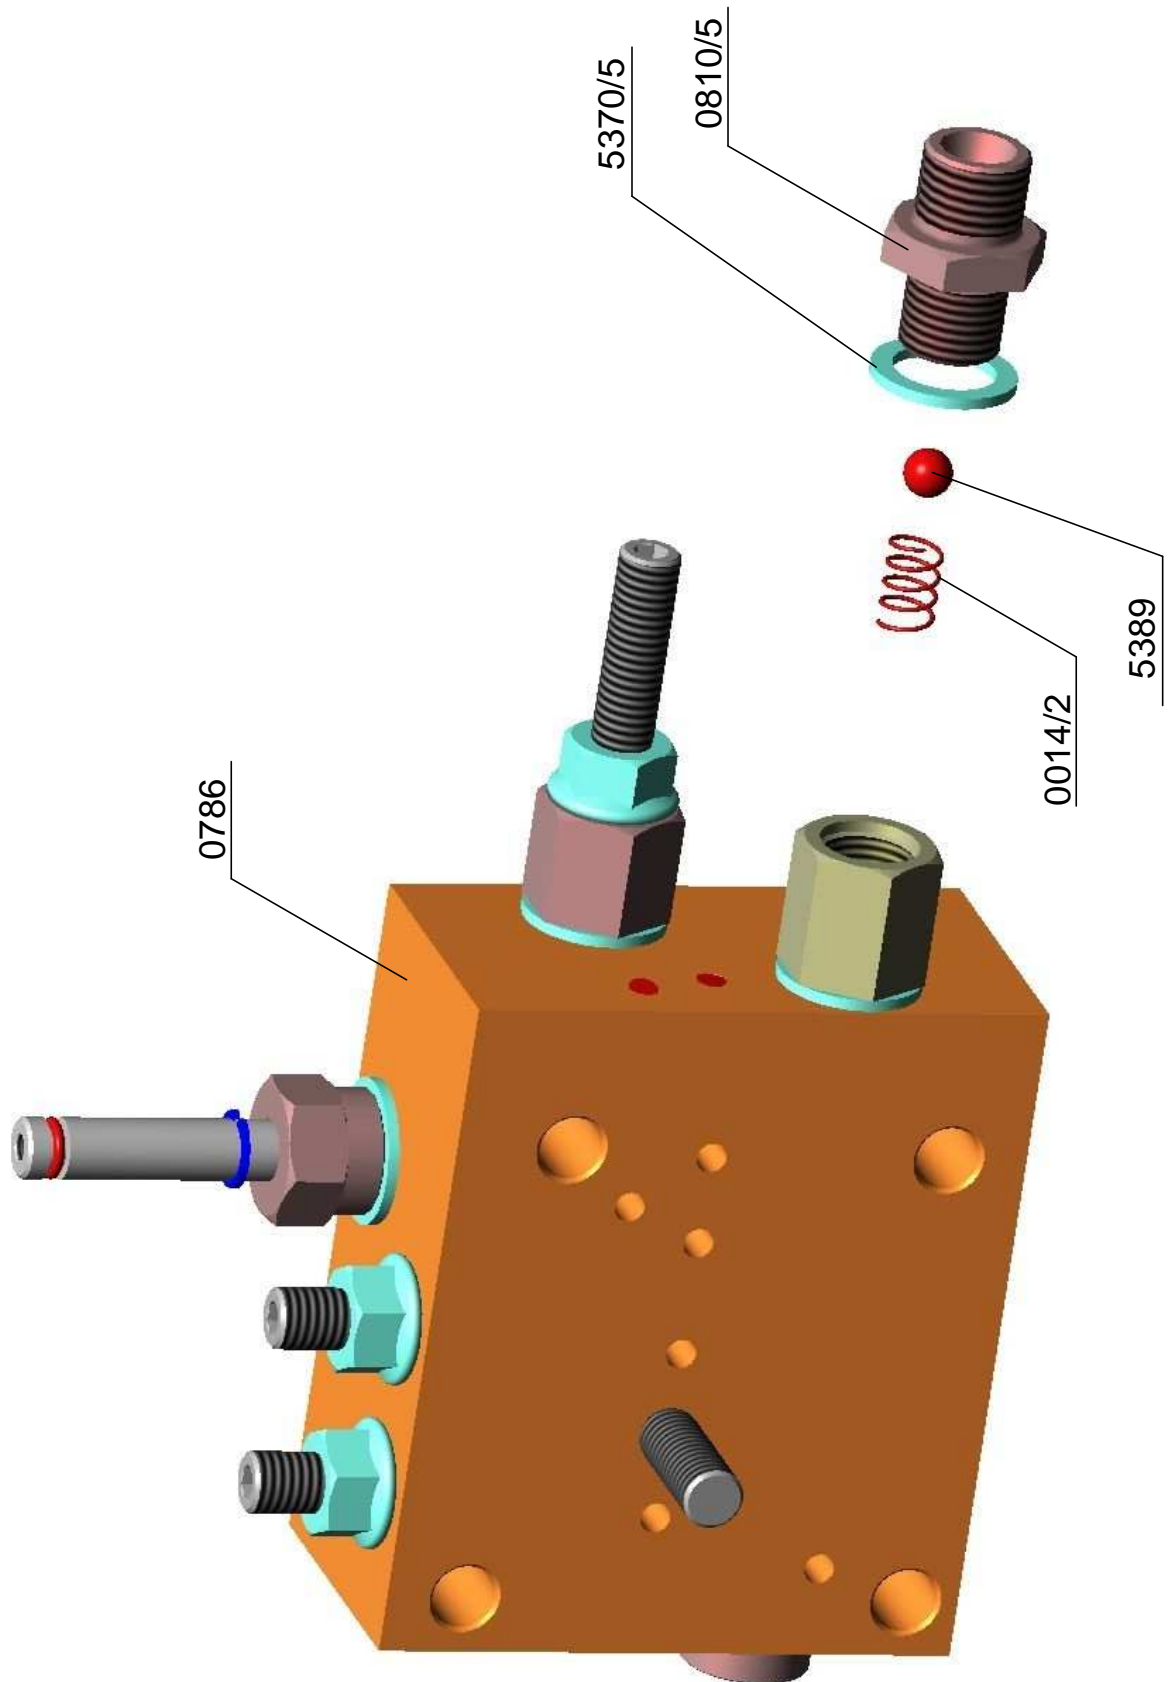
DATE
DWG Nr. <b>R8B</b>

- close the ball valve
- eliminate the pressure inside the distributor, pushing the manual descent button (0575/\* )
- switch off the motor power supply
- remove the miniflex hose from the non-returning valve of the distributor
- unscrew the distributor non-returning valve
- remove the pieces inside (both the spring and the sphere)
- clean all pieces and the non-returning valve seat from any dirt found
- if a spare sphere is available, replace the existing sphere with a new one
- assemble the components in the following order: sphere, spring and non-returning valve
- test the elevator
